Company Name: **Leopalace21 Corporation**
Representative: Eisei Miyama, President and CEO
Code Number: 8848 (Tokyo Stock Exchange, First Section)
Contact: Bunya Miyao, Director
Tel: +81-3-5350-0216
E-mail: ir@leopalace21.com

**Notice Concerning Repair Works on
Discrepancies with Construction Certificate Documents**

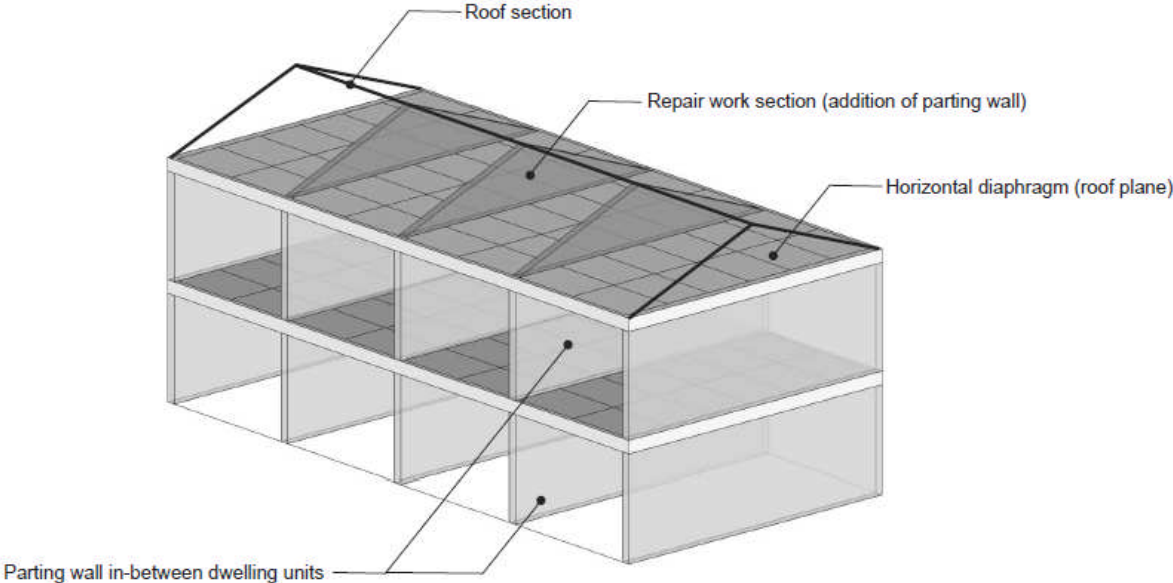
Appendix 1. Cross section of property structure

- Parting wall of small-scale attic (Appendix 1)

Parting wall* of small-scale attic shown in the construction certificate documents was not constructed.

*Parting wall is the wall that separates dwelling units (rooms). To prevent the spreading of fire, these walls must be fireproof or semi-fireproof as well as incorporate sound insulation structure, and should reach the small-scale attic or roof.

- Since the parting walls in the subject properties reach the roof structure and noncombustible materials are used in the ceiling which prevents the spreading of fire, we believe safety is secured. However, we have not obtained an objective evaluation as of this time, and therefore will promptly respond to any matters while consulting with specific administrative agencies

- Inspection of all subject properties will be carried out, and repair work will be done on properties with discrepancies with construction certificate documents, under consultation with specific administrative agencies.
- We will promptly notify the situation to owners of all subject properties, adjust the contents and schedule of repair work individually, as well as inform our occupants. We will bear all expenses related to repair work.
